3 - DRAINAGE REPORT AND PHOTOS

PLUMBING REPORT

Name William Griffin
Address 128 Poplar St.
City, State, Zip Gadsden, TN 38337

We performed a camera inspection at the above referenced property on the date noted. The purpose of this video inspection was to evaluate the condition of the homes sanitary drainage system and the following are our findings.

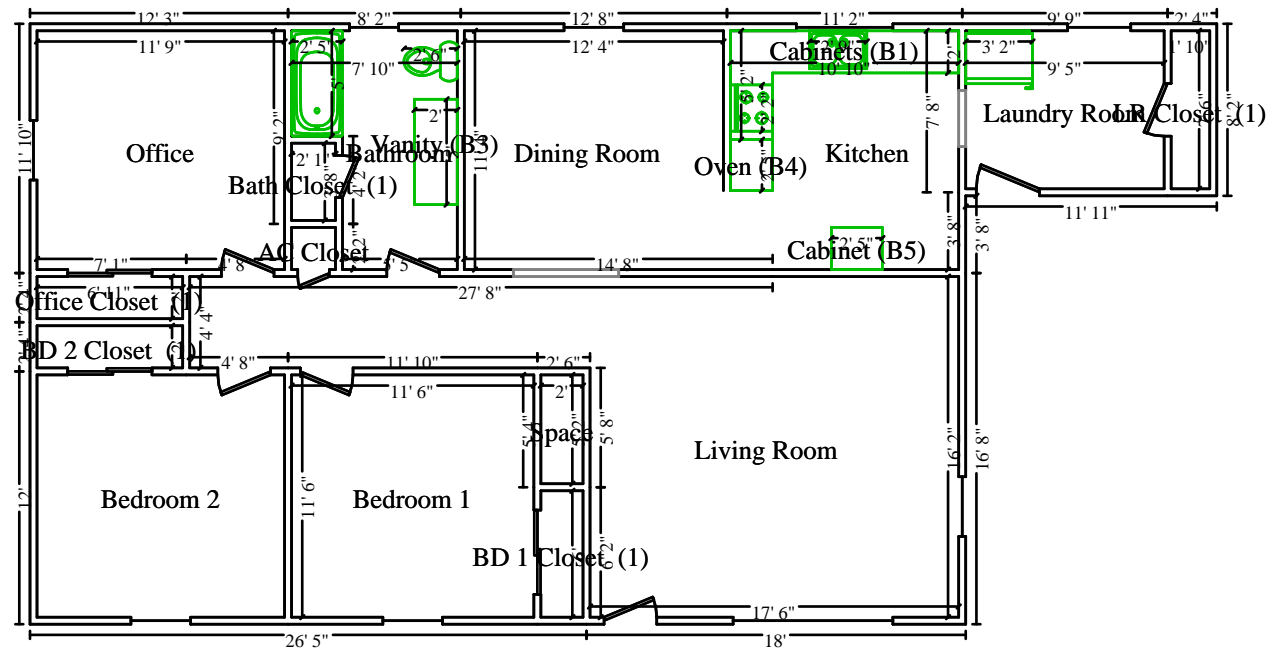
2 - DIAGRAM OF HOUSE AND PLUMBING SYSTEM

Plumbing Diagram
